**Title: Evaluation of Stop Bar Video Detection Accuracy at Signalized Intersections**

Date of Submission: November 2, 2004

Avery Rhodes  
Purdue University, Graduate Student

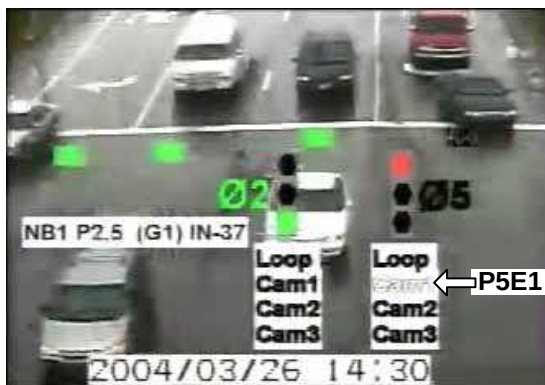
b) Undetected Vehicle on Camera 1

In Figure 6, the L1V0 errors on camera 1 corresponding to the screen captures are identified on the 24-hour L1V0 graph (Figure 6a, P5E1, P5E2, P5E3). The error P5E1 shows a missed call on the left-turn, even though there are two vehicles present (Figure 6b). This type of error, where a vehicle would not be detected, was observed frequently especially on the left turn lanes. Cameras 2 and 3 are detecting the vehicles correctly in this example.

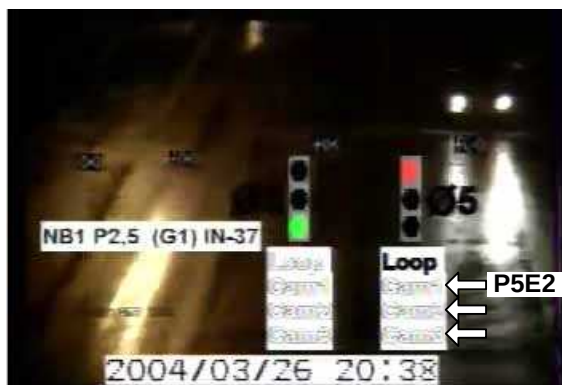
c) Undetected Vehicle at Night on Cameras 1, 2, and 3

The error P5E2 is occurring on all three cameras (Figure 6c). This error occurred after sunset and is likely because the headlights are not bright enough or large enough to be detected.

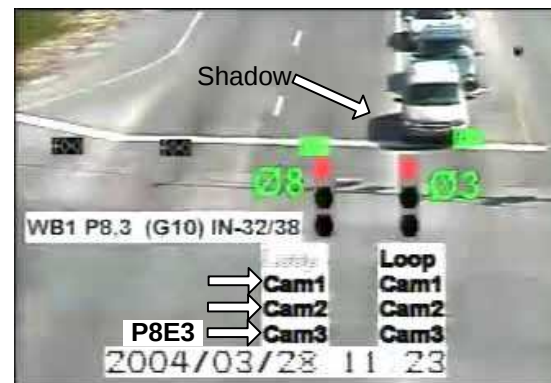
d) False Call on Phase 8, Camera 1, 2 and 3, Triggered by Shadow of Left-Turning Vehicles

The second error (P8E3) is caused by the shadows from the vehicles in the left-turn lane. In this case, all three cameras have placed a false call.
