## Evaluation Of Selected Video Detection Systems At Signalized Intersections

### FHWA/IN/JTRP-2001/22

EVALUATION OF SELECTED VIDEO DETECTION SYSTEMS AT SIGNALIZED INTERSECTIONS

November 2001

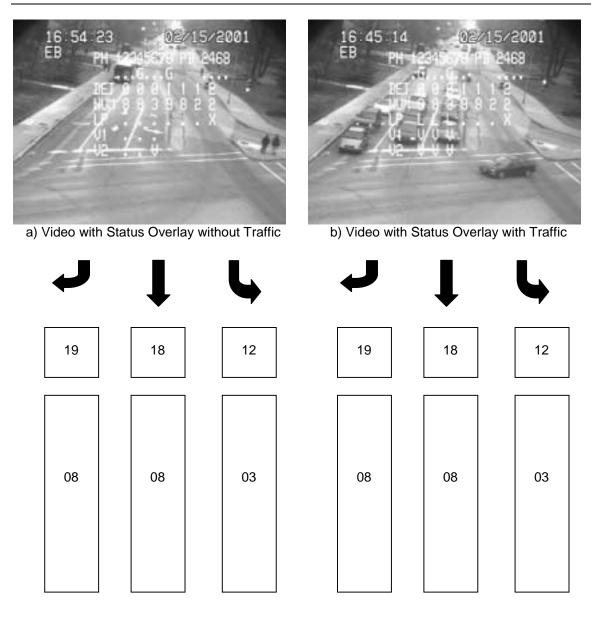
c) Detector Layout

Figure 3-26: Eastbound Detector Layout

Figure 3-24, Figure 3-25, Figure 3-26, and Figure 3-27 show the northbound, southbound, eastbound and westbound approaches and their detector layouts, respectively.

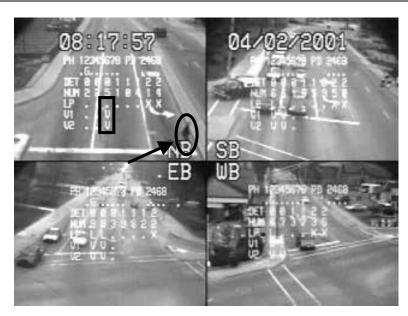
instead of inside the pedestrian crosswalk. This has caused both video detection systems to indicate a vehicle's presence. In areas where there is a high incidence of pedestrian crossings, and specifically, within the video detection area, this could cause a major efficiency problem for the intersection. Most video detection systems are equipped with a function that will check for directionality. By using this function, this would help to alleviate most of the pedestrian detections, since they are not walking in the same direction of the traffic flow.

Figure 4-3: Example Screen Capture of L0V1 Error Caused by Video Detection of Pedestrian (Northbound Left Turn Lane, System 1, After Recalibration)

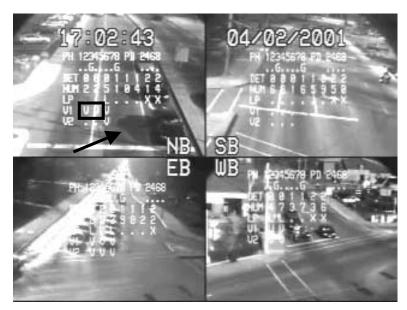
Figure 4-4 illustrates the negative effect that shadows can have on video detection. In this figure, the shadows from the vehicles in the left turn lane are causing Video Detection System 1 to indicate the presence of a vehicle. Again, this would cause an efficiency problem for intersections that are operating at mid-to-full capacity.

Figure 4-4: Example Screen Capture of L0V1 Error Caused by Vehicle Shadows (Northbound Through Lane, System 1, After Calibration)

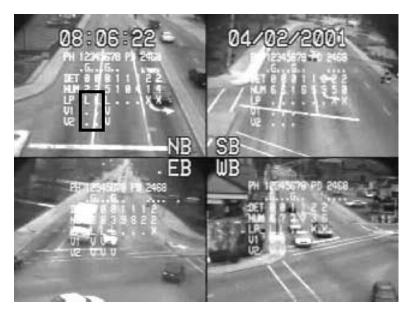
Figure 4-7, illustrates the same purpose that Figure 4-5 did. Either the inductive loop detectors in the northbound through lanes are too sensitive, and are registering the presence of vehicles in the northbound left turn lane, or they are faulty detectors.

Figure 4-7: Example Screen Capture of L1V0 Error Caused by Loops (Northbound Through Lanes, After Recalibration)

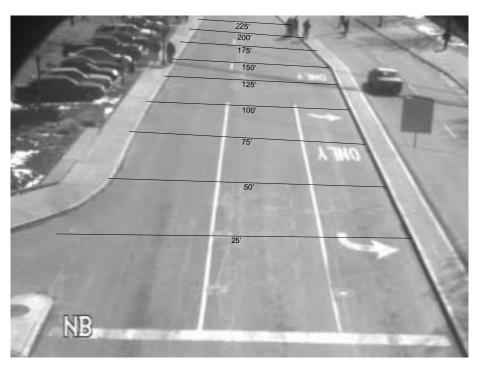
from the stop bar (approximately 50 ft), with no outliers. One can see that before the recalibration, the detection distances were further from the stop bar, and more spread out. After the recalibration, the detection distances moved closer to the stop bar, and the spread of the detections was less. It should be noted that the Autoscope 2004 unit has a feature called "Night Reflections." The purpose of this feature is to reduce the effect that vehicle headlight glare has on vehicle detection. This feature was not enabled before the recalibration, but was enabled during the recalibration.

Figure 6-29: Distances from Stop Bar on Northbound Approach

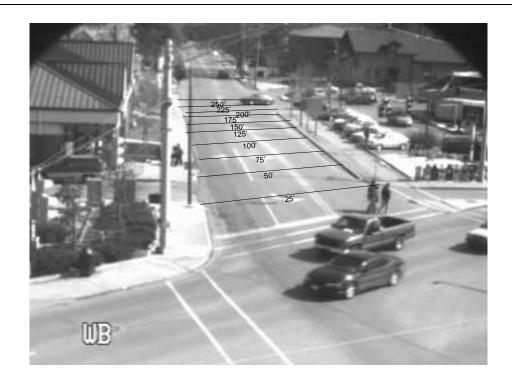
Figure 6-32: Distances from Stop Bar on Westbound Approach

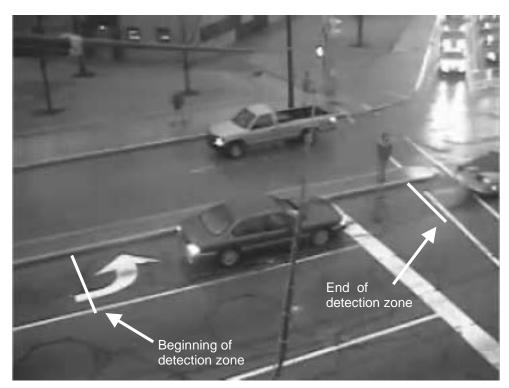
from the onset of data collection. Whenever a vehicle entered the empty detection zone, the start button was pushed on the calculator. When the last vehicle in the detection zone left, the stop button was pushed. The observer also counted the number of vehicles entering the detection zone. Data were aggregated in fifteen-minute intervals. At the end of each data collection (two hour segments), the calculator was hooked to a PC, and the data was uploaded into a spreadsheet program.

Figure 7-4: Screen Capture of Northbound Left Turn Lane During a Ground Truth Data Collection
