**City of Anaheim/Caltrans/FHWA  
Advanced Traffic Control System Field  
Operational Test Evaluation:  
Task C Video Traffic Detection System**

**California PATH Research Report**

**UCB-ITS-PRR-98-32**

Video Traffic Detection System

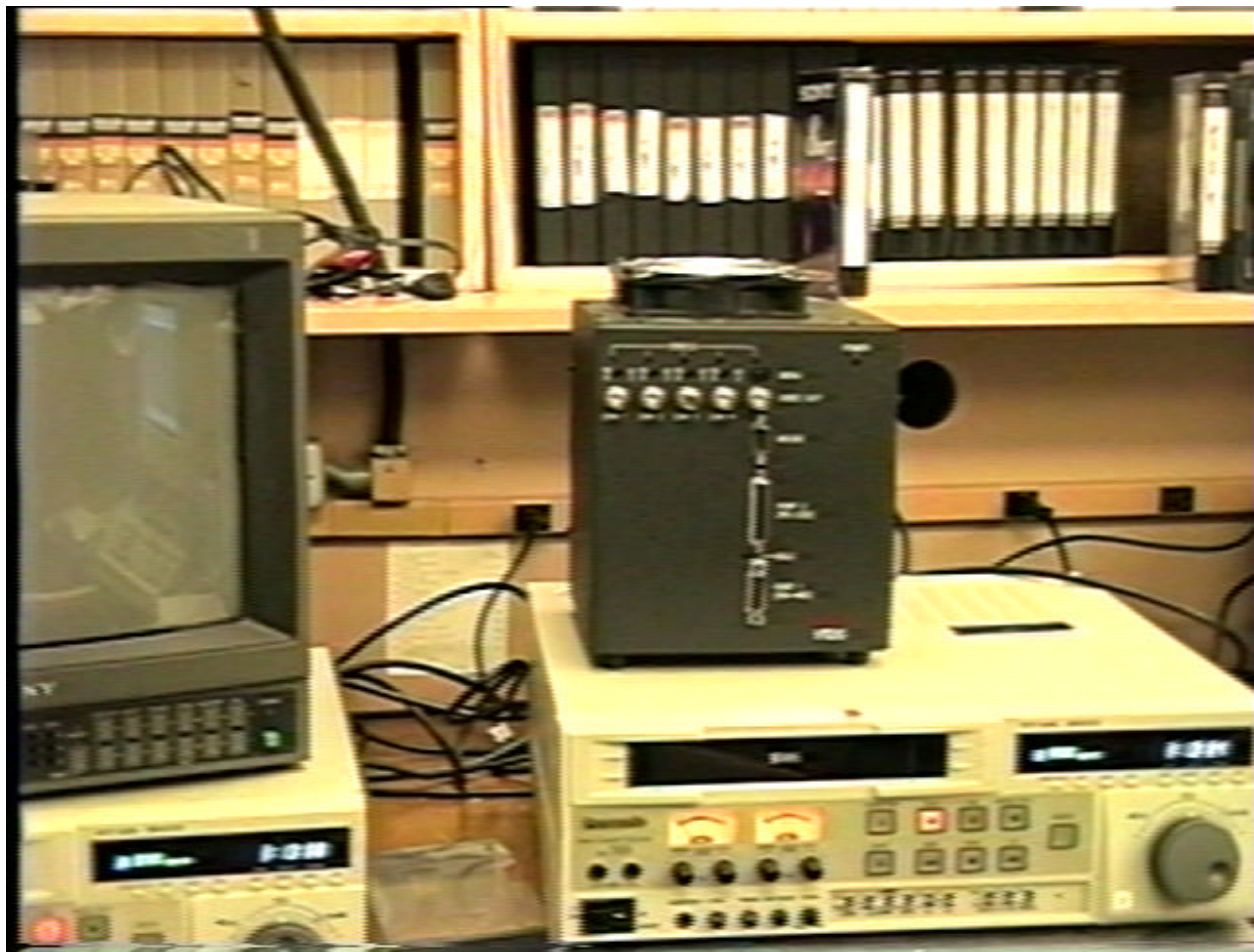
**Figure 1. Odetics VTDS Evaluation Unit (on top of video tape recorder).**

Following the November 1996 EOT meeting, we took delivery of a VTDS evaluation unit at Odetics' Anaheim facility. Odetics staff confirmed that the unit was fully operational, with the most recent firmware available, and was properly calibrated. Figure 1, below, is a single video frame from our documentary video records showing the evaluation unit prior to setup for testing at the Cal Poly Transportation Electronics Laboratory.

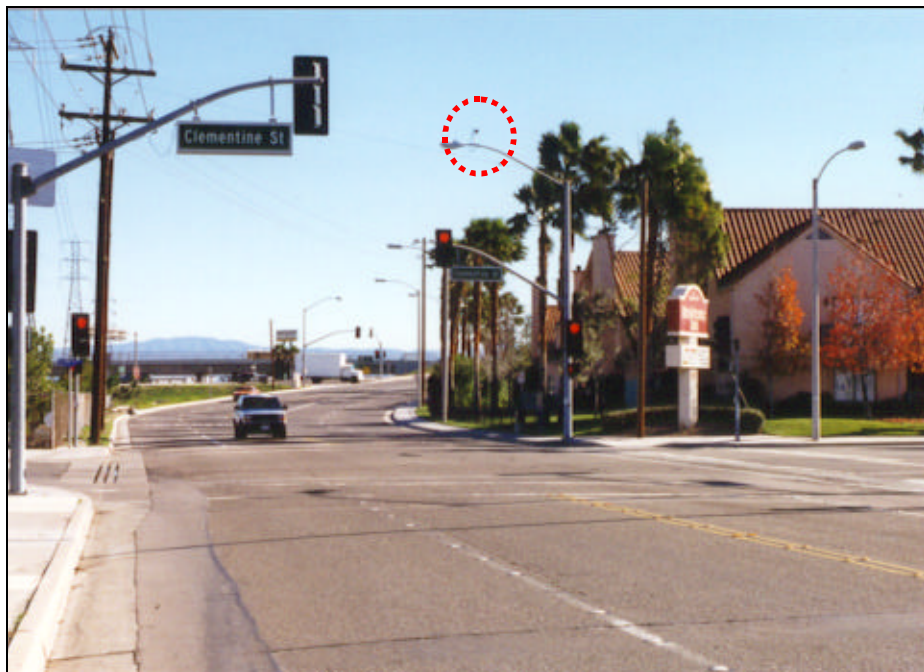
**Figure 6. Clementine and Freedman Test Intersection.**

Figures 5 and 6 below are ground-level photographs of the Harbor/Katella and Clementine/Freedman test intersections, at which most of the test conditions were recorded. The positions of the VTDS cameras in each photograph are highlighted by dashed circles.

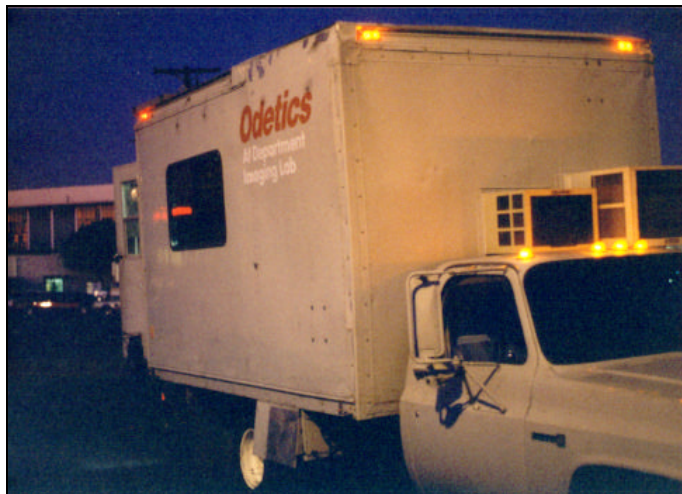
**Figure 9. Mobile Laboratory Exterior.**

At the Odetics facility we also inspected the mobile surveillance laboratory, as required under FOT Task 9. At the time of our inspection, the vehicle appeared to no longer be in use for this application. Two monitors, one VTR, and a few other unconnected equipment items in a rack mount frame and miscellaneous materials storage were observed. The interior and exterior of the vehicle were photographed for documentary purposes, and are shown respectively in Figures 9 and 10 below. It does not appear from our inspection that this trailer was being employed in the field testing of the VTDS Intersection Product. Since the vehicle can only be parked on the side of a roadway, it could not be used for acquisition of video sequences usable by the VTDS Intersection Product, which requires camera placements in the roadway centers of intersection approaches. It is suitable for and was probably utilized for the development of the earlier version of the VTDS, which was specified as a general purpose data collection and signal actuation detection system.

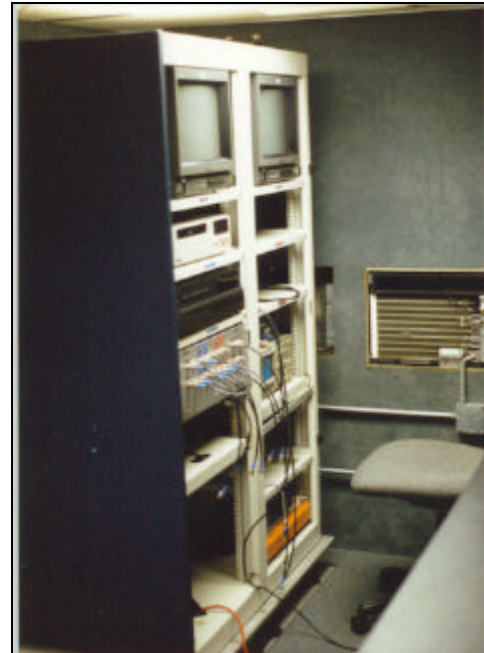
**Figure 10. Mobile Laboratory Interior.**

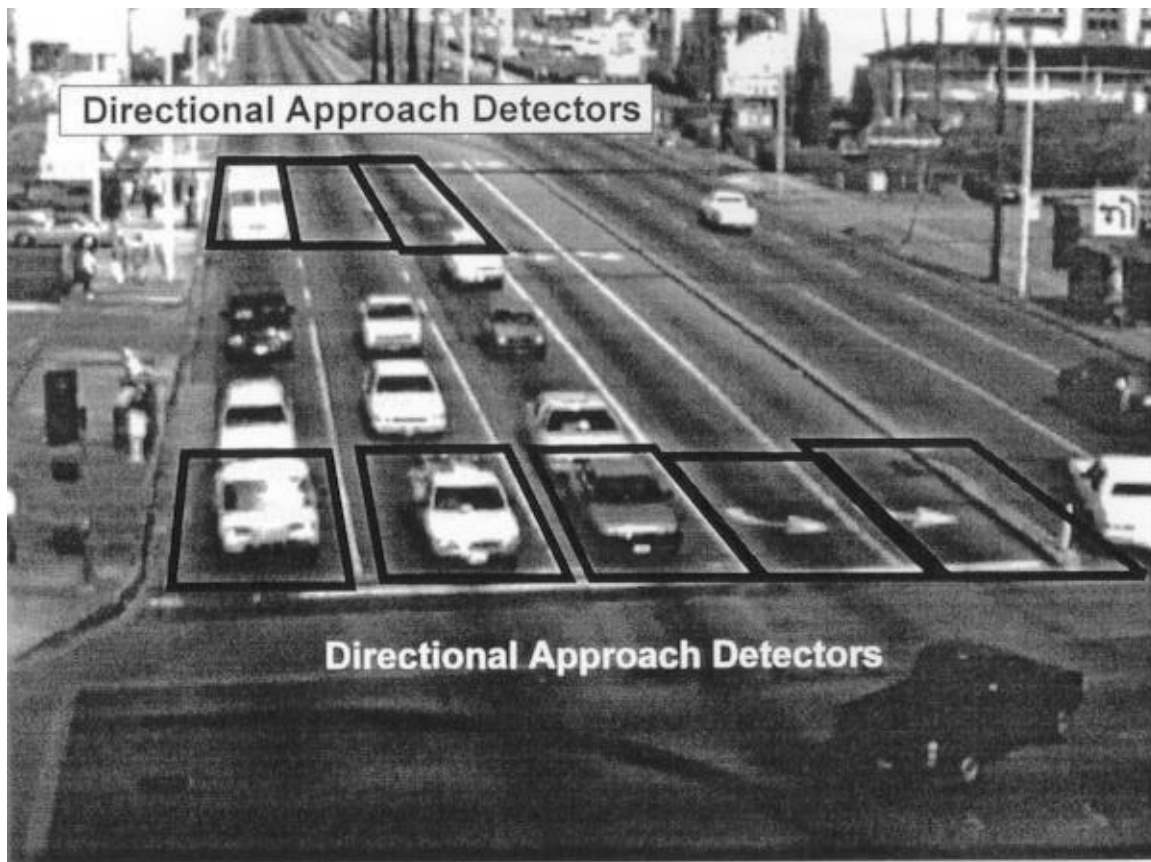
**Figure 12. Example of Ideal Setup for Stop Bar and Advance Detection Windows, Reproduced from Operating Instructions for Odetics VTDS.**

An typical detection zone placement for both types of windows is shown on Page 17 of the “Operating Instructions, Intersection Product, Vantage VTDS” [8], duplicated as Figure 12 below.
